# Chapter 12

## **PHYSICAL INTEGRITY OF WATER**

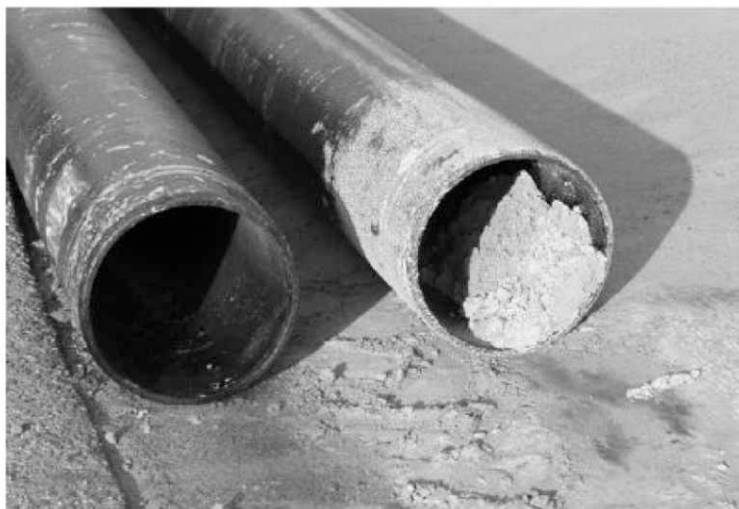
**Figure 12.1: Backfill sand contaminating a new pipe at a water main construction site**

A second major cause of physical integrity loss is human activity surrounding construction, repair, and replacement that can introduce contamination into the distribution system. Any point where the water distribution system is opened to the atmosphere is a potential source of contamination. This is particularly relevant when laying new pipes, engaging in pipe repairs, and rehabilitating sites. For example, a Midwestern water utility experienced a noticeable increase in the heterotrophic bacterial population of water from a newly installed pipe and identified *Pseudomonas fluorescens*, *Ps. Maltophilia*, and *Ps. putida* as the bacteria responsible for the increase (Pierson, Martel. et al. 2001). The same strains of *Pseudomonas* were recovered from the sand used as an aggregate in making the concrete lining for the new ductile iron pipe, implicating contamination during construction and installation. More recently, workers in Camden, New Jersey, were cleaning and lining a 30-inch water main when a parallel sewer line from the post-Civil War era broke. Because of the proximity of the sewer line and the possibility of contamination, officials decided to issue a boil-water alert until water quality testing could show that no external contamination had entered the main. Between 1997 and 1999, the Philadelphia water supply measured elevated turbidity ( $>1$  NTU) in about 12 to 14 percent of the samples that were collected from newly installed water mains. This turbidity, or the particulate debris captured on filters, was found to be largely iron oxides and rust (from the existing water mains still in service), vegetable material such as plant roots, and backfill sand.

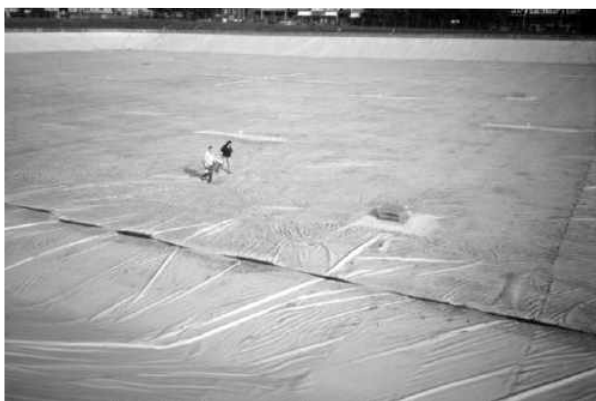
**Figure 12.2: Preparing to sample stored drinking water from the access hatch of a floating cover on a distribution system reservoir**
